# Beca Establishes Real-time Monitoring, Ensuring Safety and Efficiency on Christ Church Cathedral Reinstatement

iTwin<sup>®</sup> IoT Visualizes Data Gathered during Work on the Unstable, Earthquake-devastated Structure

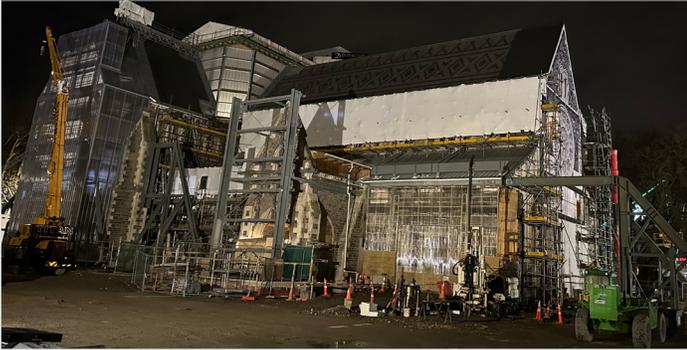
Real-time sensor data reduces the risk to people and infrastructure. *Image courtesy of Beca.*

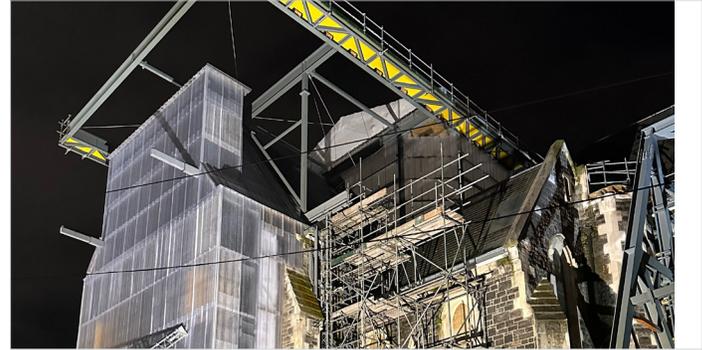
Bentley IoT and the sensor data has resulted in 50% fewer trips to the site for troubleshooting. *Image courtesy of Beca.*
